Manhole Inspection Summary

Manhole # S13A__013MH

Insp Date: 1/21/09 11:55 AM

Location Address: **701 POPLAR GROVE**

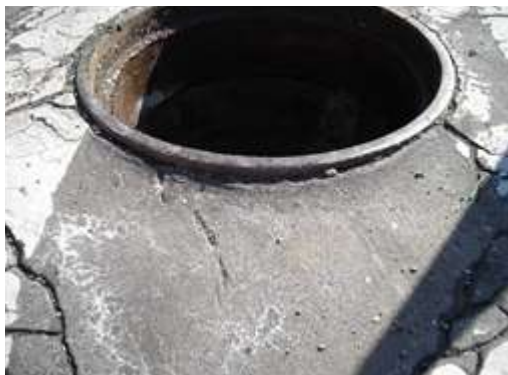
MANHOLE SITS 1" ABOVE GRADE ON UPSTREAM SIDE

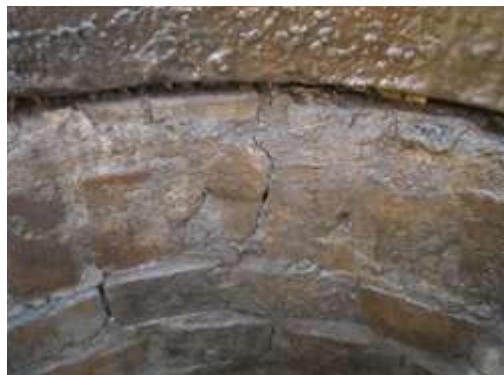
Defect 3

Condition: ☐ Sound ☒ **Cracked** ☐ Root Intrusion ☐ Loose Brick ☐ Deteriorated

CRACKED CORBEL

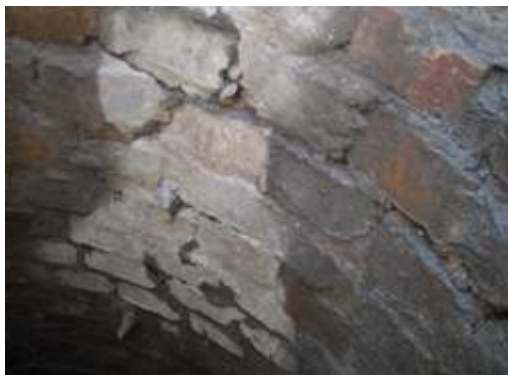
Defect 2

Condition: ☐ Sound ☒ **Cracked** ☐ Root Intrusion ☐ Loose Brick ☒ **Deteriorated**

CRACKED AND DETERIORATED BARREL

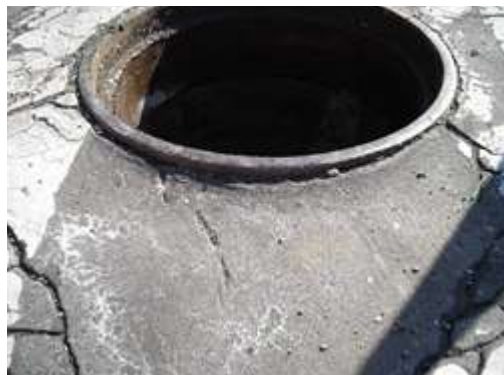
Defect 1

GRADE

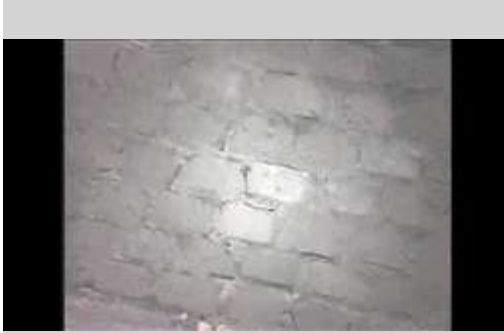
Defect 3

CRACKED AND DETERIORATING
BARREL WALL

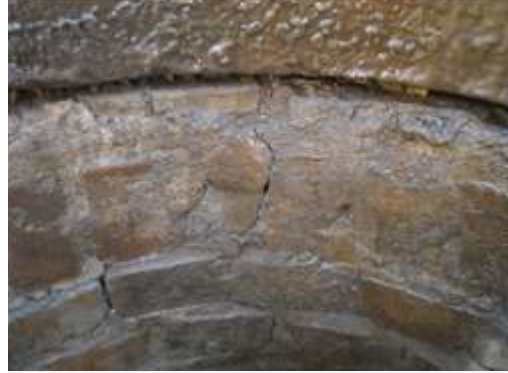
Defect 2

MISSING MATERIAL BELOW FRAME

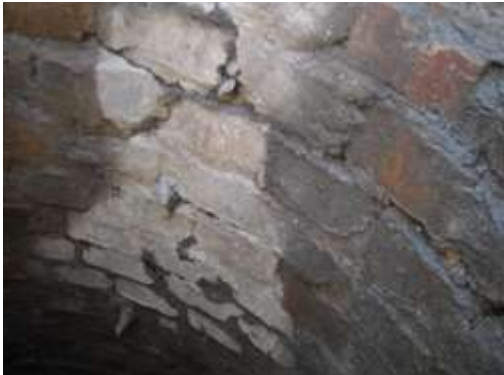
Defect 1

CRACKED AND DETERIORATED
CORBEL WALL

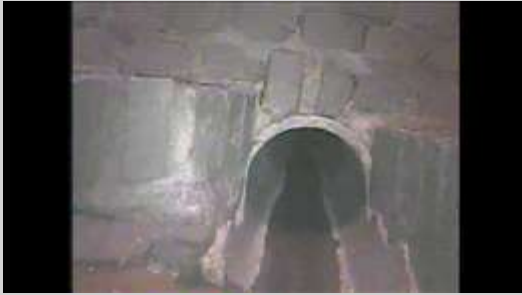
12 O'Clock Outflow

Pipe Height: **8.4** (in.) Rod and Bar (Angled)
Pipe Material: **Clay** ☐ Pipe Lined
Invert Depth: **6.98** (ft.) Flow Characteristics: **Slow**
Deposits: ☒ None ☐ Mud ☐ Sludge ☐ Debris ☐ Grease
Silt Depth: (in.) Deposits Extent:
Infiltration: **None** Pipe Seal Cond: **Cracked**

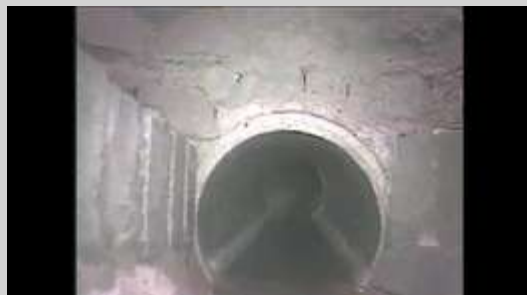
9 O'Clock Inflow

Pipe Seal Cond: **Cracked**
